## UNDERSTANDING YOUR BONANZA FUEL QUANTITY INDICATOR SYSTEM

## 1962 thru 1969 models

### 1970-and-after models

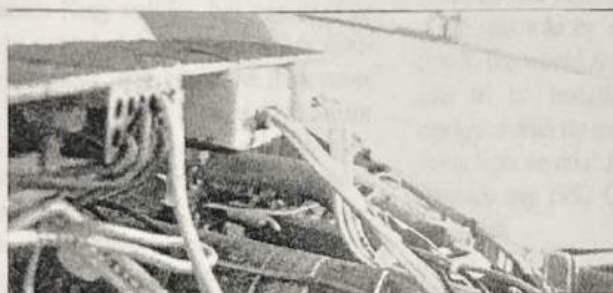
Figure 4 - Printed circuit modules 1970 and later

Each side's transmitters are attached to a printed circuit module mounted above the fuel gauges under the angle mount for the glare-shield support (Figure 4). On the rear lefthand side of each module is a slotted adjustment that allows the full indication to be adjusted on the indicator.

If the gauge becomes flaky and bounces around or is completely dead, it is often the printed circuit module. It is relatively easy to swap the connectors on the back of the left and right modules to help isolate the problem module. If the fault goes with the module, it is time to send it out for repair. Birks Aviation Products (309-686-0614) rebuilds and exchanges these modules for a flat \$430. Birks advertises in the classified-ad section of the *ABS Magazine*.
